The Effect of Welding Defects on the Long-Term Performance of HDPE Pipes

Abstract: High-density polyethylene (HDPE) pipes are the preferred pipes of water systems in nuclear power plants because they are durable, corrosion-free, easy to install, and not subject to fouling. However, their long-term performance can be affected by welding defects. In this paper, the effect of welding defects on the long-term performance of HDPE pipe butt fusion joints was studied using a creep test. A welding defect with a hole or inclusion in the joint was simulated by artificially inserting a copper ball during butt fusion welding. The test results showed that the creep life of the joint decreased with increased defect size. An expression describing the creep life and the defect ratio was obtained according to the test results. In addition, the test results showed that the creep life of the joint without a welding bead was about 50% of that in a joint with a welding bead.

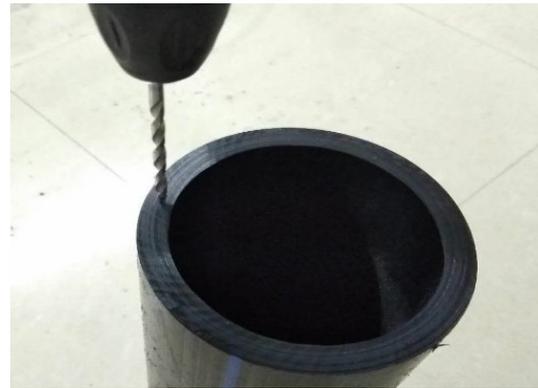
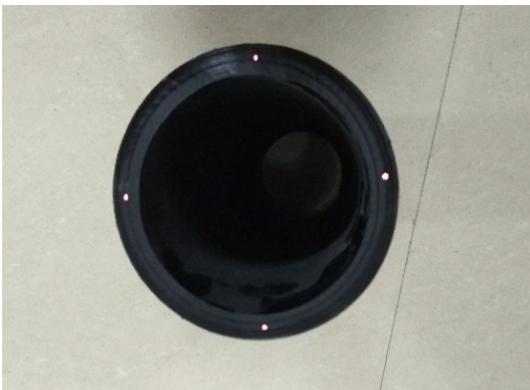
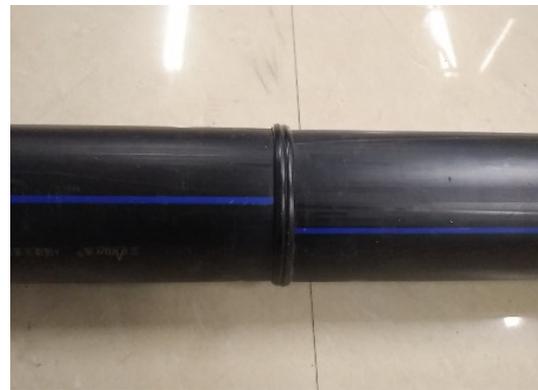
(a) Milling and cleaning the welding surface

(b) Drilling holes

(c) Inserting the copper balls

(d) Butt fusion joint after welding

Figure 1. Process of inserting defects into the butt fusion joint of HDPE pipes.**Table 2.** The defect diameter, wall thickness, defect ratio and creep life of the specimens.

HDPE pipes made from PE100 were used in this study. They had an outer diameter of 200 mm and SDR (the ratio of the outer diameter to the wall thickness) of 11. The melting temperature, T_m , was 131 °C, the crystallization temperature, T_c , was 117 °C, and the degree of crystallinity was 67%. The yield stress was 22.2 MPa, the Poisson's ratio was 0.4, and Young's modulus was 1314 MPa at an air temperature of 28 °C. The HDPE pipes were welded according to ISO 21307 [23] and the welding parameters are shown in Table 1. The welding was performed on a butt fusion welding machine (HDC160–315, Zhuji Huida Pipeline Technology Co. Ltd., Zhuji, China). More details on the welding process can be found in ISO 21307 [23]. Copper balls were inserted into the welding surface before welding in order to simulate welding defects such as holes or inclusions. The steps of inserting the copper balls are shown in Figure 1a: milling and cleaning the welding surface; Figure 1b drilling holes in the center of the welding surface (the diameter of the holes was identical to that of the copper balls); Figure 1c inserting the copper balls; Figure 1d creating the butt fusion joint after welding. The ratios of the diameter of the copper balls to the thickness of the pipe wall were 0%, 16%, 33%, and 44%, respectively. Here, 0% indicates that there was no welding defect in the joint. Four copper balls were inserted into the joint to prepare enough specimens in one joint and reduce the effect of welding quality on the test results. The defect sizes are listed in Table 2.
